Reducing injury risks associated with underground coal mining equipment

An outcome of ACARP Project C18012

Robin Burgess-Limerick PhD CPE • Burgess-Limerick & Associates • October 2010

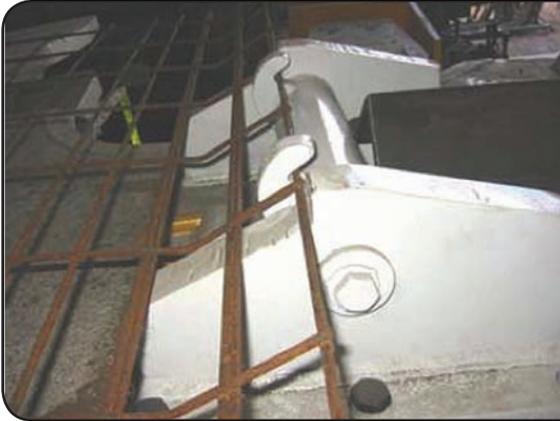
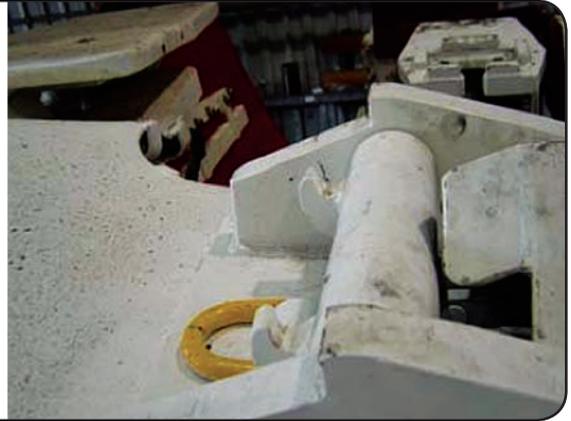
"Mesh grabber" innovation

An additional risk highlighted at a focussed recall session, and subsequently observed, is reaching under unsupported roof whilst handling mesh into place on top of the continuous miner. The “mesh-grabber” innovation presented by Kestrel at the 2005 QLD Mining Safety conference (Rio Tinto Australia, 2005) has potential to eliminate this hazard by allowing the mesh to be raised with the canopy.

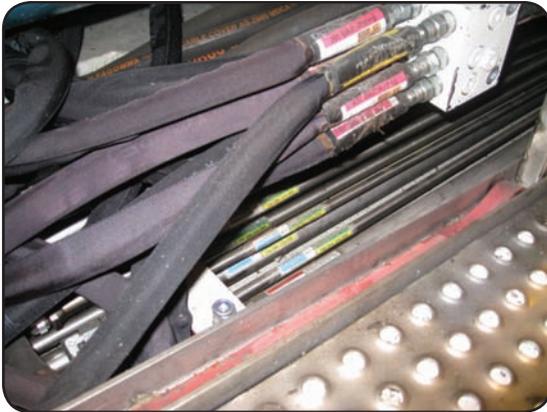
Replacing hydraulic hoses with stainless steel piping where possible

Being struck by hydraulic fluid is also an injury mechanism of considerable concern because of the serious consequences of fluid injection injuries. Control measures put in place to reduce this risk include substitution of hosing with piping, and isolation of miners from hydraulic hosing.

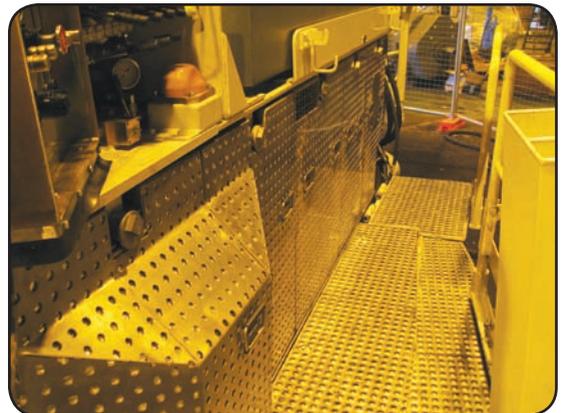
Stainless steel covers isolate miners from hosing and include noise attenuation materials

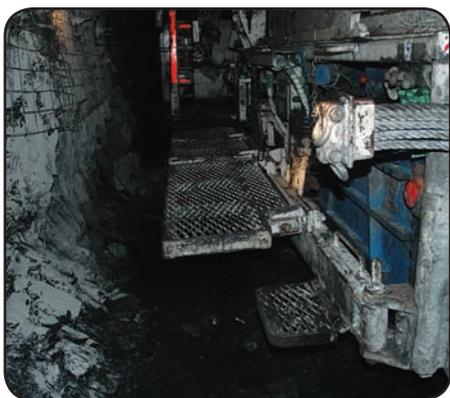
Hinged platform and access step

Hinged steps are provided on some miners (and are frequently broken off). Access systems should be designed to comply with AS3868 (bottom step < 400 mm above the ground, three points of contact). Provision of ladder access may preferable for high platforms where compliance with this standard is

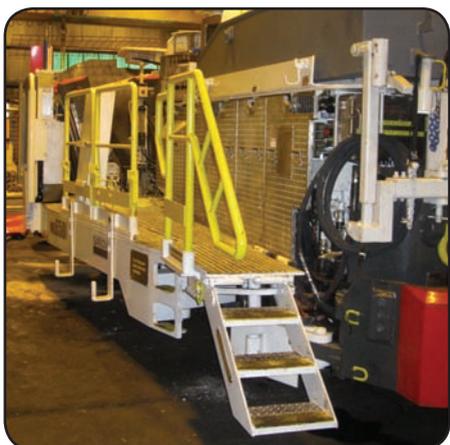
Sandvik MB650 step access

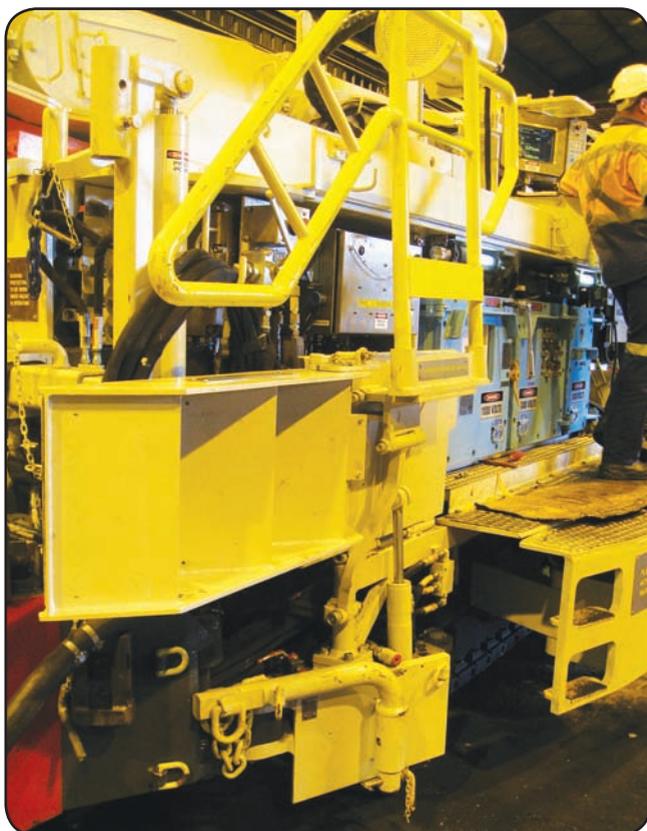
MB650 steps folded for breakthrough

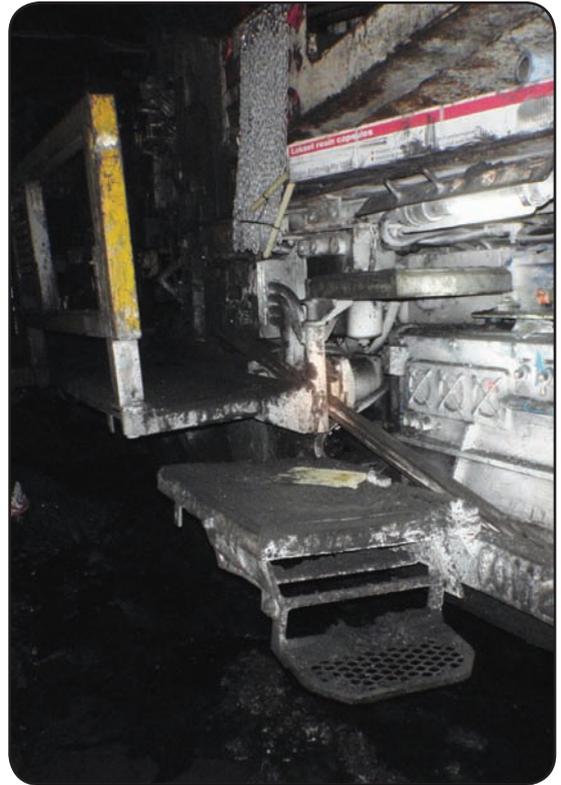
Step access and handrails

Handrails have been retrofitted at some sites and are typically incorporated in new equipment. While MDG 1 specifies handrails should be provided for platform heights above 1.2m, the injury statistics suggest that this is insufficiently protective, and handrails are justified for all platforms.

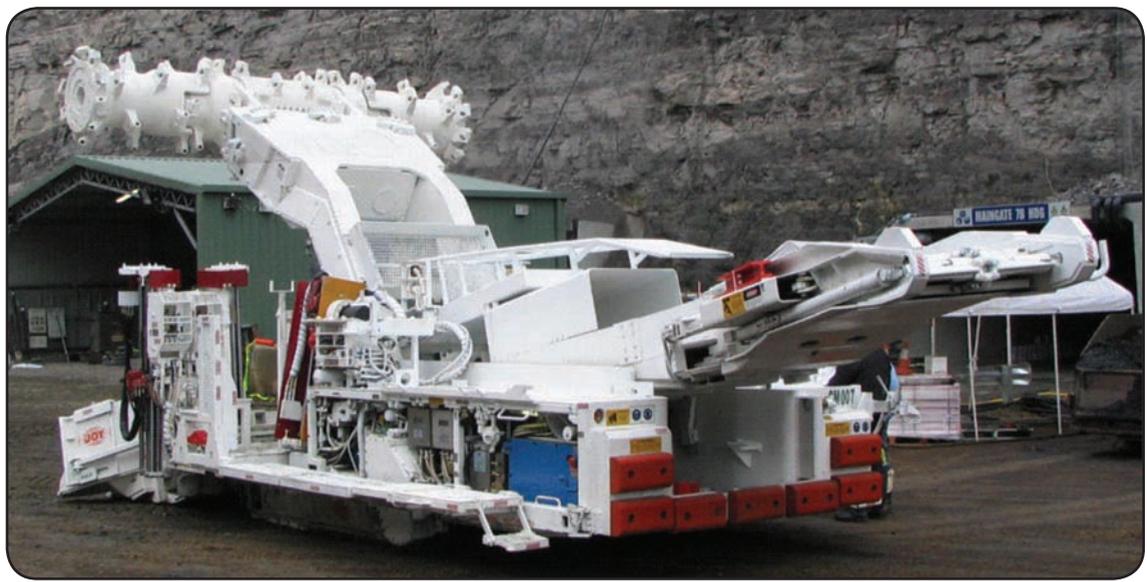
Single level platform and rear step

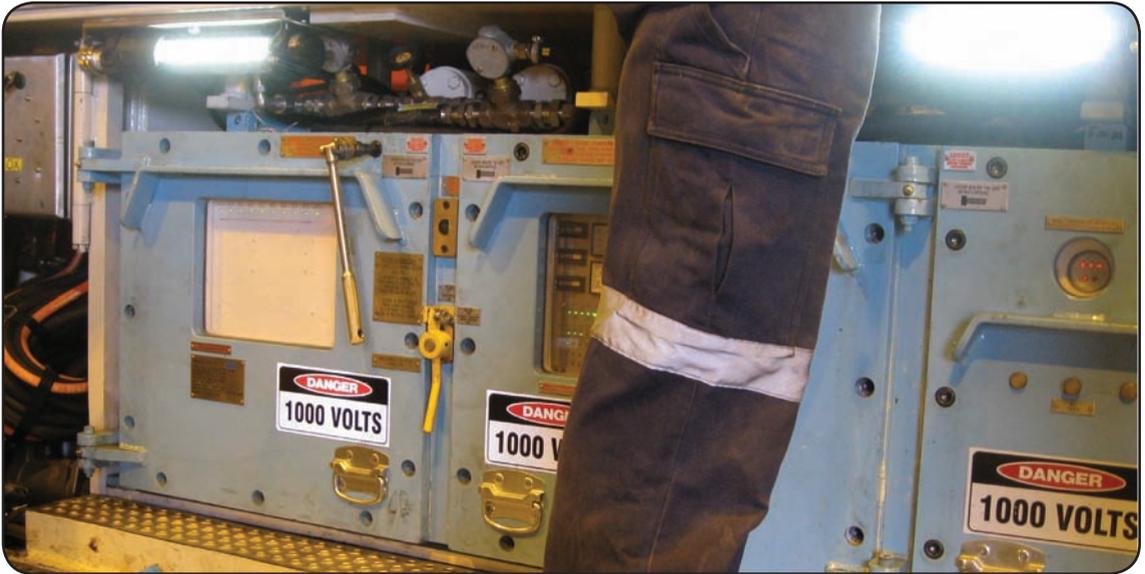
Continuous miner platform lighting

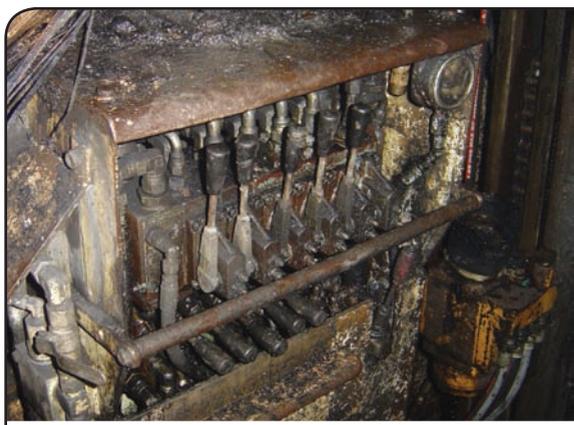
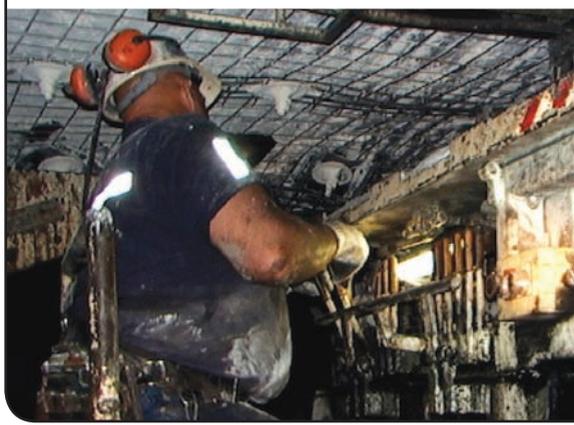
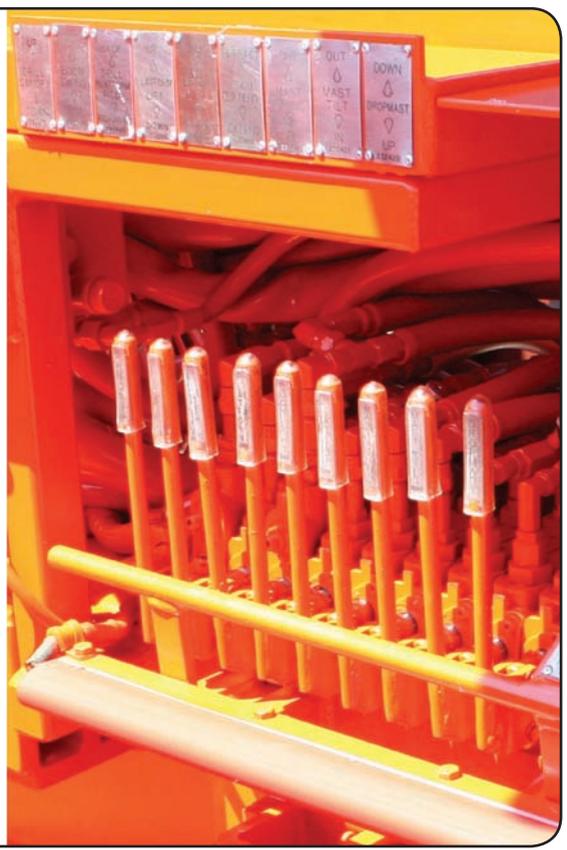
Too much guarding may inhibit access

A bank of similar controls increases the probability of operator error

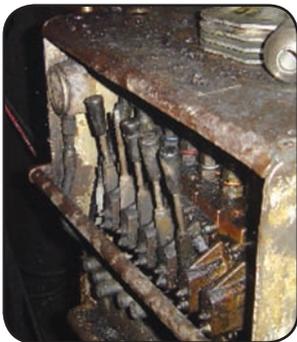
Shape coding through a missing knob

At one site visited during the current project, shape coding had been undertaken by an operator, who had placed a plastic cap over the end of one control. At another site it was observed that one lever was missing a knob, which has a similar effect, although whether this was deliberate or not is unknown. With the inclusion of shape coding in drafts of the MDG35 revision, manufacturers have offered shape coding for retrofit to existing equipment, and new bolting rigs.

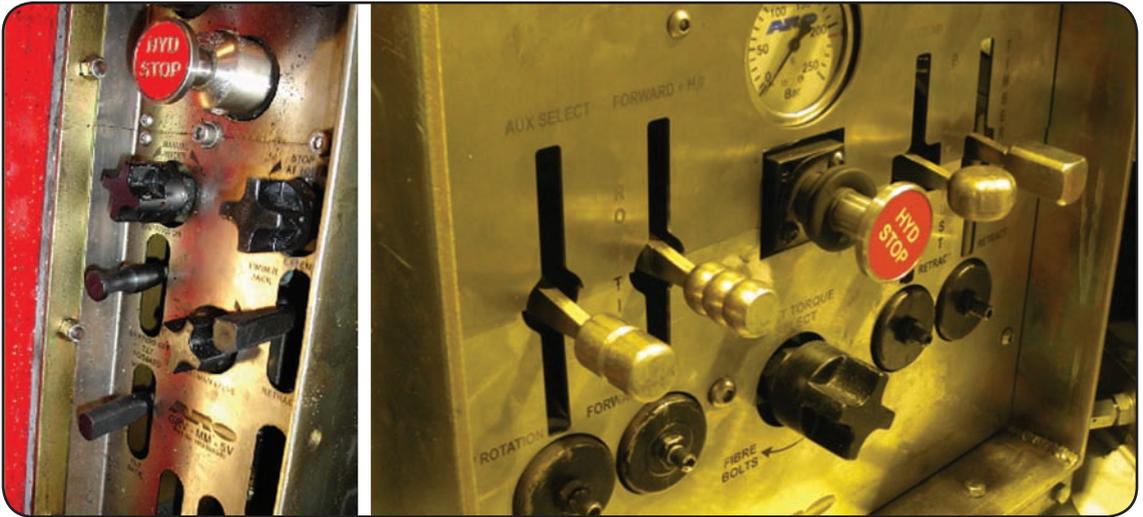
Shape coding of bolting controls

The potential effectiveness of shape coding in reducing selection errors was focus of a ACARP project 16013 (Burgess-Limerick, 2009). The results of this project demonstrated that beneficial consequences of shape coding are likely in situations in which the relationship between shape and function is constant, but the location of the controls is altered: either by changing to a different workstation; or a different machine (Burgess-Limerick et al., 2010a). Consequently it is important to ensure that the relationship between shape and function is standardised, and that a means is provided to prevent shaped handles being placed on the incorrect lever.

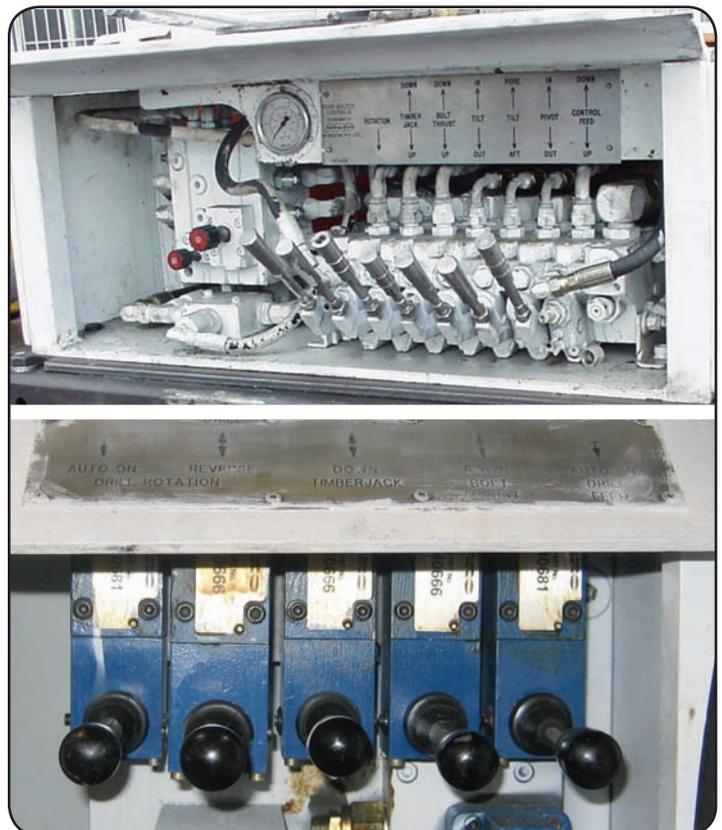
Variations in directional relationships for bolting.

The issue is not straight forward. It is relatively common on mining equipment to find situations in which downward movement of horizontal control lever causes upward movement of the controlled element such as a boom, timber jack or drill steel. While some authors (e.g. Helander et al., 1980) have suggested that this is a violation of compatible directional control-response relationships, Simpson and Chan (1988) suggested that the response may be compatible if the operators assume a “see-saw” mental model of the situation, where moving the near end of the control downwards causes the far end (and the controlled element) to move upwards.

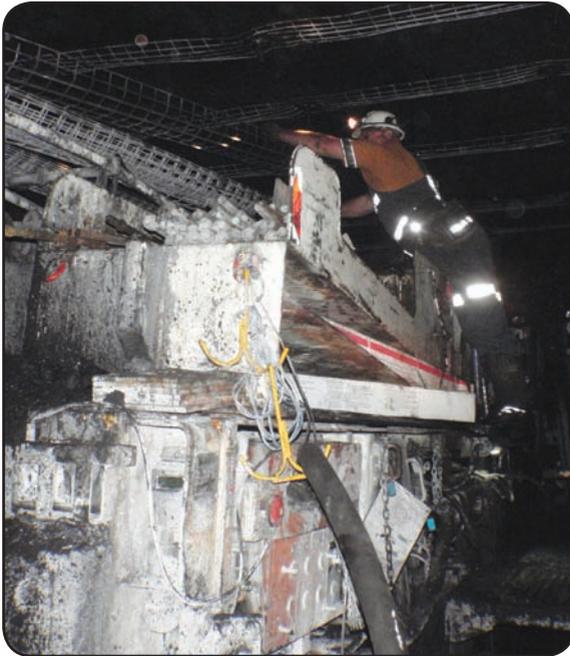
Handling mesh into position typically involves awkward postures

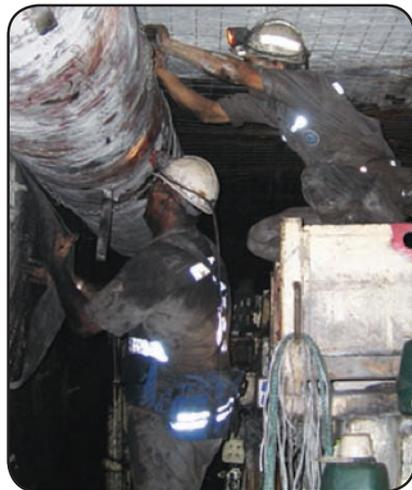
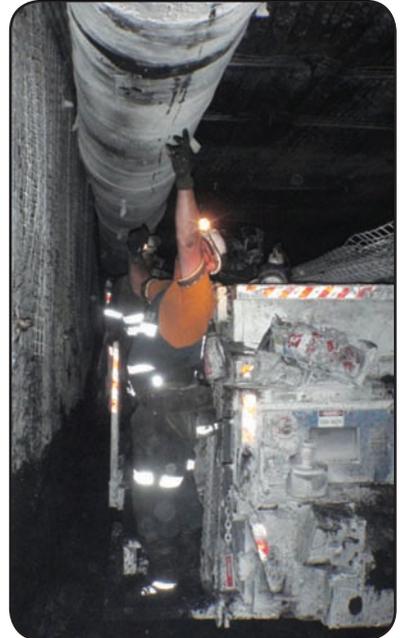
Installing vent tubes requires awkward postures and forceful exertions

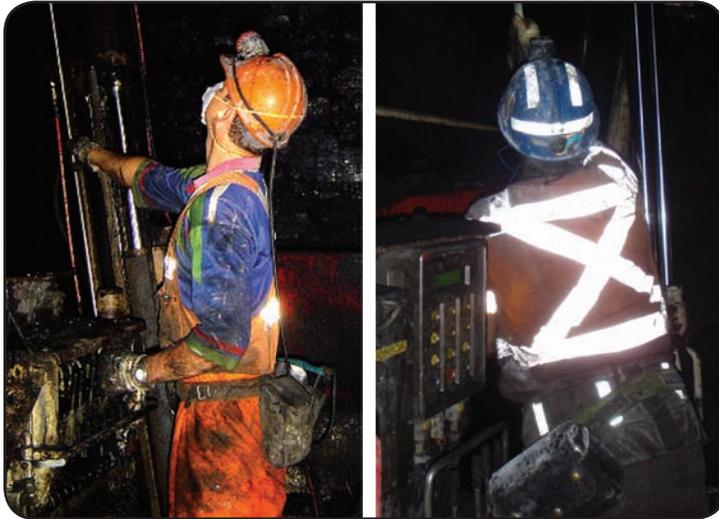
Handling drill steels and bolts at a distance from the body increases the risk of shoulder injuries.

Strains during bolting are likely to occur because of prolonged exposure to high shoulder load moment (mass x distance). Shoulder load can be reduced by reducing the reach distance required to access the drill pots. This reach distance varied considerably across continuous miner models observed. Redesign of platforms and bolting rig controls has been undertaken to improve access and mast mounted drill rig controls and rotation of the drill pots also reduce injury risks.

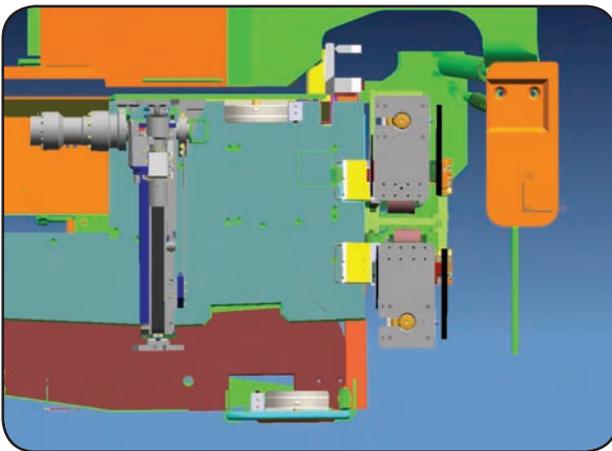
Increased platform space has potential to reduce reach distances during bolting.

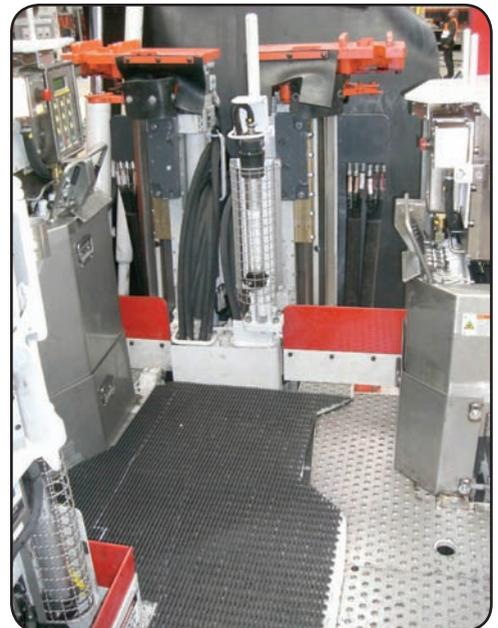
Most mounted control and rotated drill pots reduces reach distance.

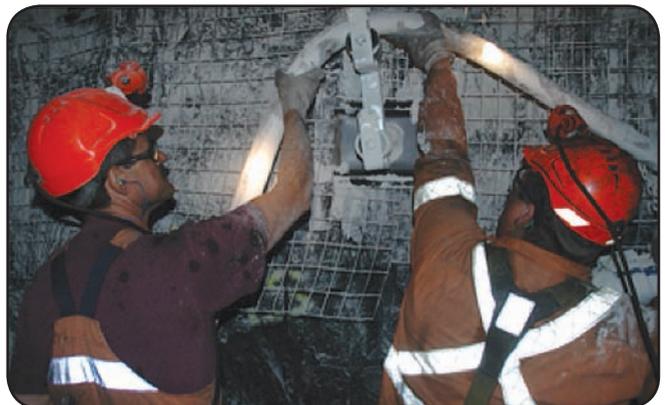
Handling cable is a common cause of shoulder and back injuries

Strains while handling was the most frequent cause of injury associated with continuous miners. The majority of these injuries involved handling continuous miner cable (32 injuries per year in NSW). The severity of injuries associated with handling cable varies from relatively minor shoulder strains to serious back injuries. Whilst the cumulative nature of most musculoskeletal injuries implies that other manual tasks are likely to have also contributed to these injuries,

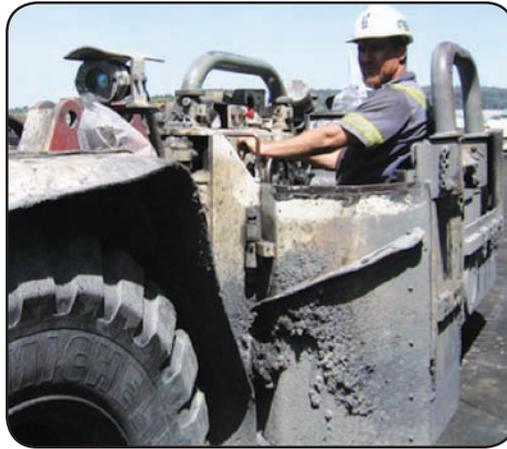
Rotated neck posture caused by side-one seating

The sideways seating position used in LHDs requires prolonged exposure to a rotated neck posture (Eger et al., 2010). This can be reduced by providing some degree of seat rotation. 30 deg rotation in seat has been provided in some refits, and in new vehicles. Dual seats allowing the driver to face the direction of travel are provided on an MPV. The SMV Brumby provides a permanent 20 deg seat rotation to reduce neck rotation during the predominant travel direction.

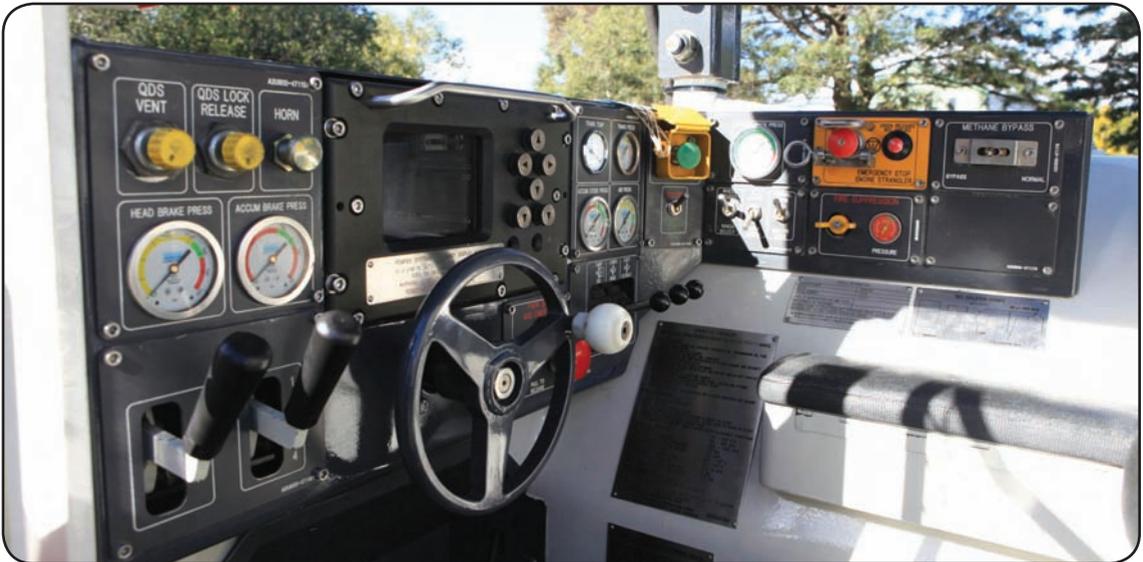
Improved LHD cab ergonomics

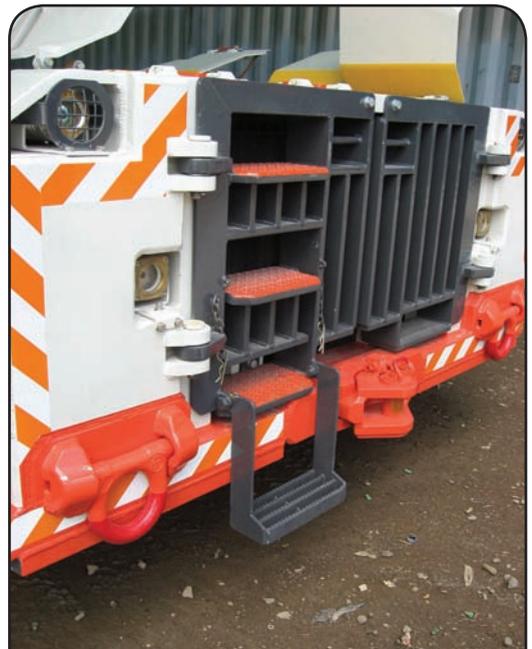
Improved maintenance access

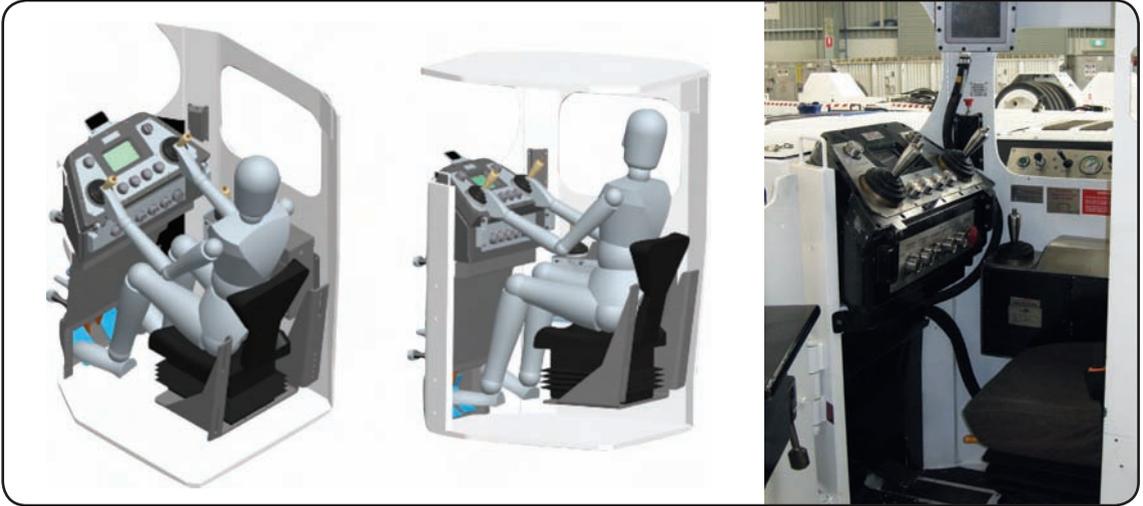
Bucyrus "ergo cab" designed for compact loader range

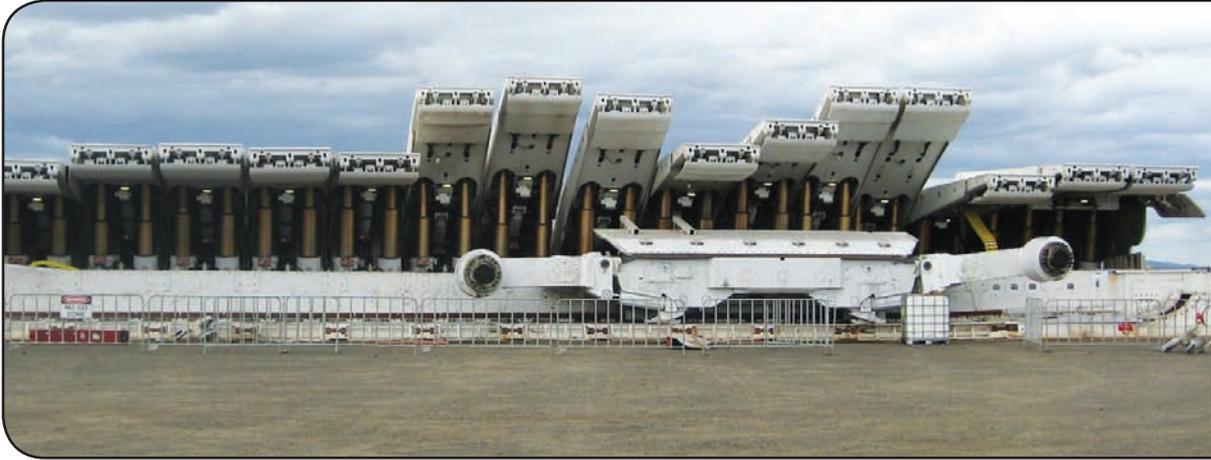
Longwall mini-build

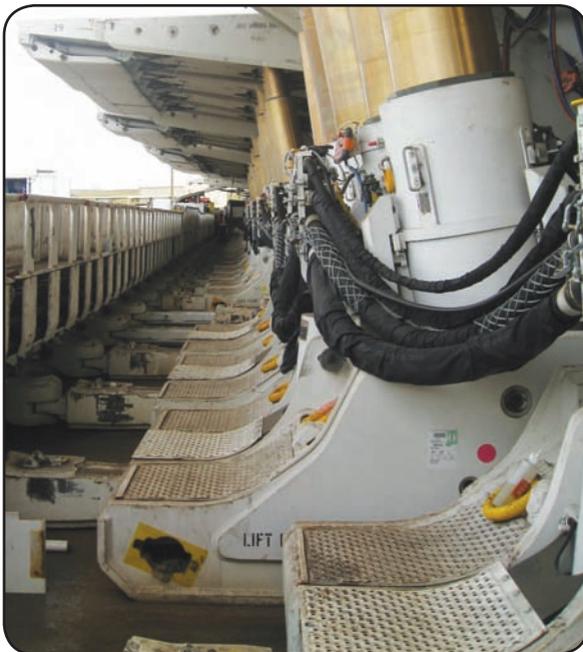
Reduced tripping hazards on front walkway

Although difficult, efforts have been made to reduce tripping hazards on the longwall face through, for example, provision of walkway lighting, and placing covers between the toes on the front walkway. Handles have been provided on one face to assist moving from front to rear walkways.

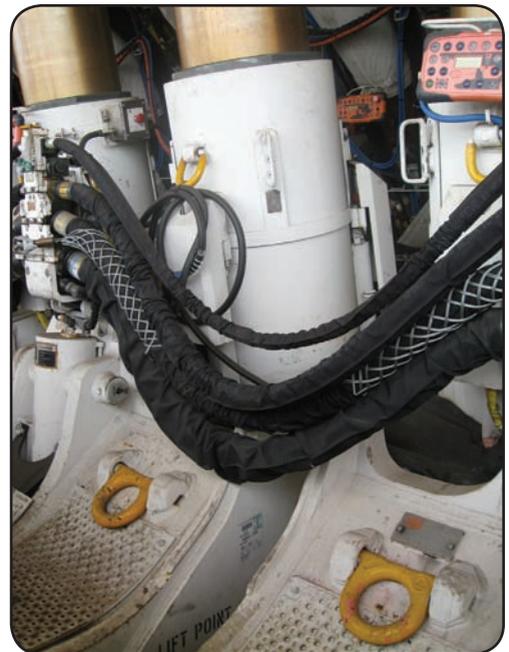
Handles to assist movement between front & rear walkways

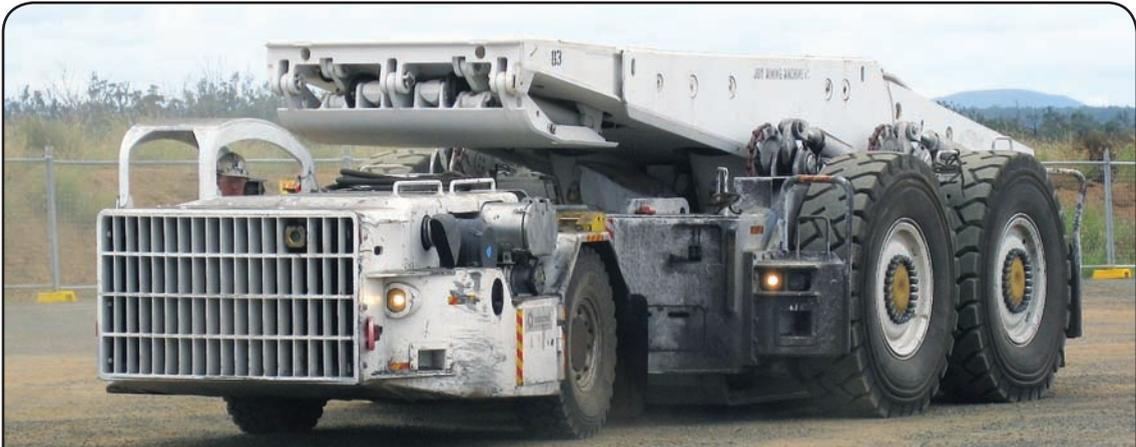
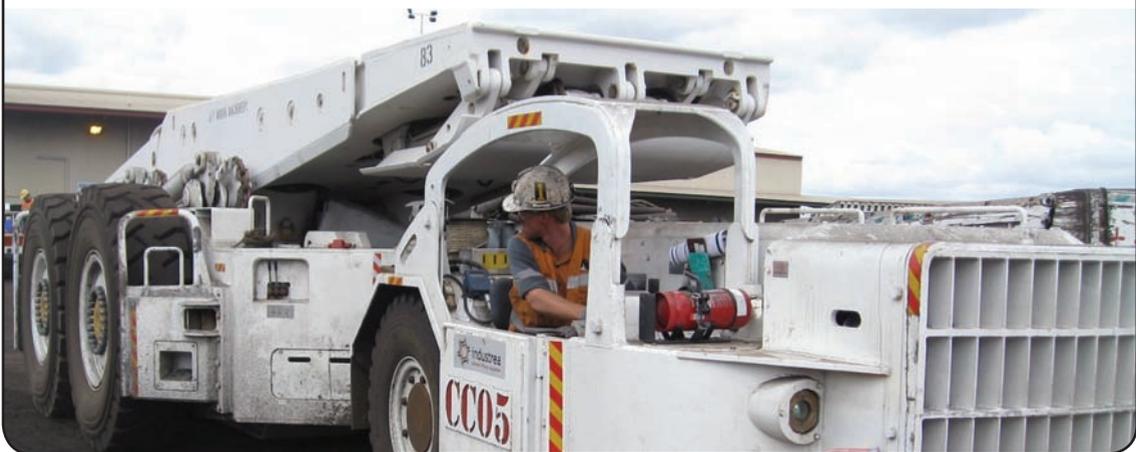
Chuck carriers

Field of view of video cameras provided for Industree Chuck Carrier

Vehicles provided to move longwall chocks have greatly restricted visibility. Video cameras are being provided to overcome these issues to some degree.

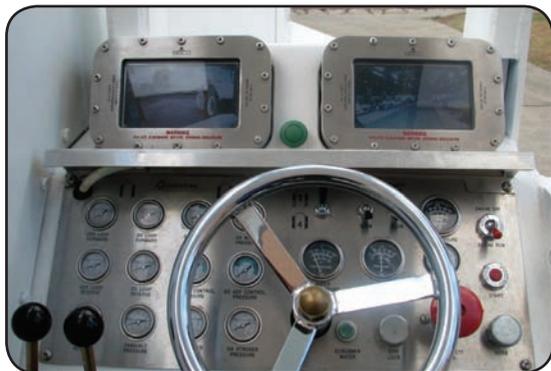
Video displays provided to driver

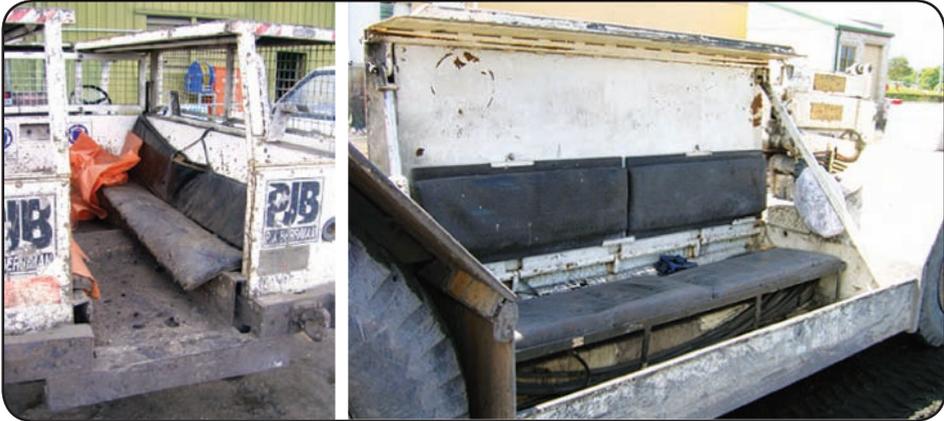
Poor seating increases risks of both acute and cumulative injuries

Control measures to reduce this jarring and vibration (in addition to roadway maintenance) include improved shock absorbers and thicker cushions, and complete suspension and seat redesign (Dayawansa et al., 2006). The SMV transport redesign undertaken at Kestrel with ACARP funding has the additional advantage of seating passengers facing forwards and backwards. Either provide superior safety if a collision occurs. Dayawansa et al. also developed concepts for new underground transport vehicles as part of ACARP project CI4037.

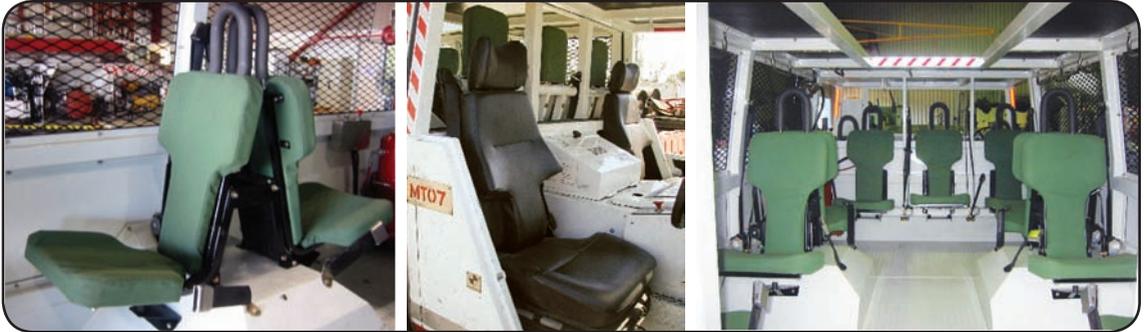
Redesigned SMV transport vehicle (Dayawansa et al., 2006)

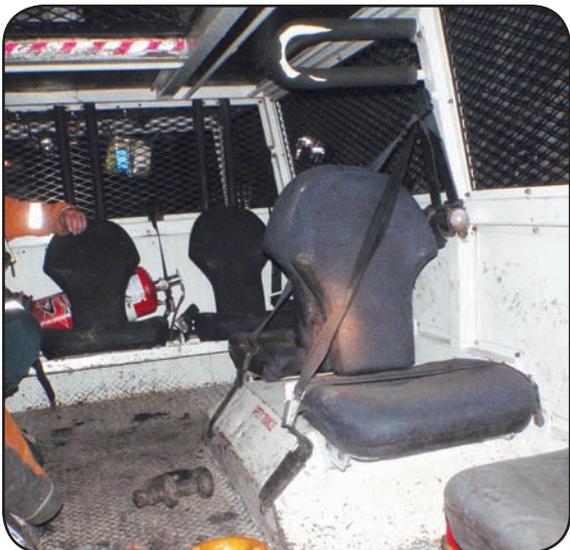
Forward & rear facing seating

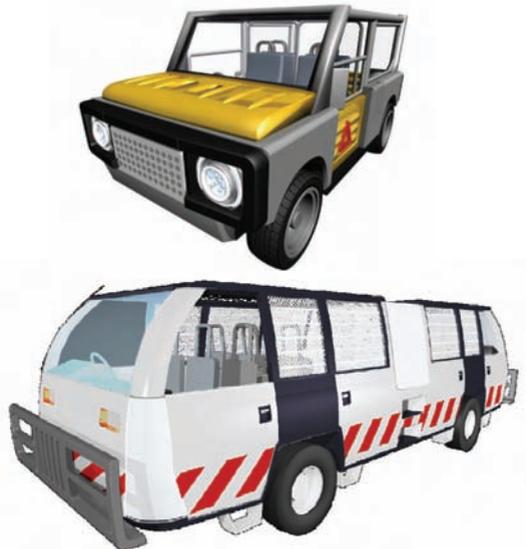
Concept vehicles (Dayawansa et al., 2006)

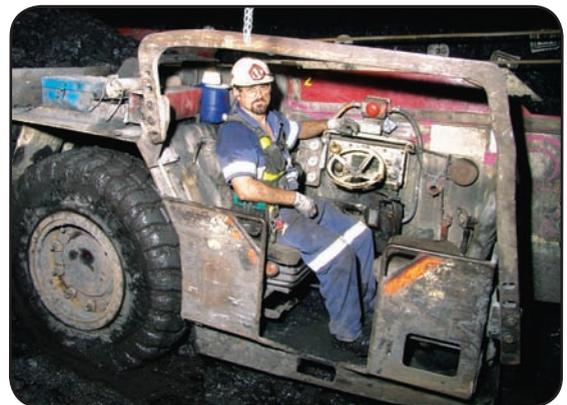
Typical shuttle car cab currently in use

The steering mechanism in use in these cars features an incompatible directional control relationship. When driving out-by (sitting in the

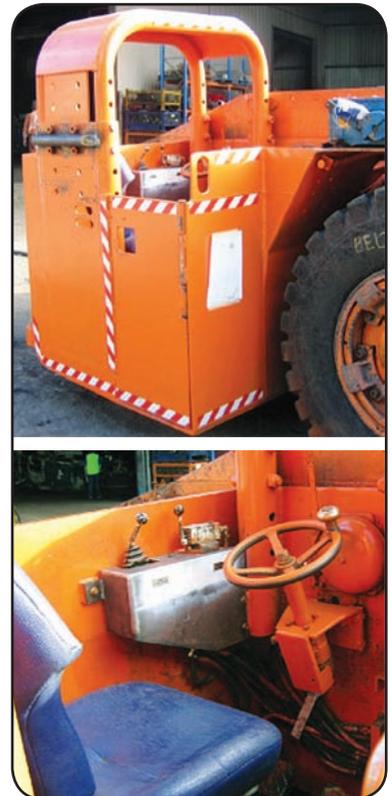
East-west cab fitted to shuttle car (Beltana)

Arising from initial work undertaken by Beltana, Joy 10SC32BC shuttle cars feature a single “east-west” facing seat (above) and enclosed cab. In these cars a left foot brake, right foot tram arrangement is used, with a single rocker throttle used to control tram direction and acceleration. The directional steering incompatibility remains. Side facing seating has the disadvantage of exposing operators to an awkward neck posture for prolonged periods, a likely cause of discomfort and a risk factor for neck injury. These cars featured a suspension system based on a strut of elastomeric pucks and urethane dividers on a steel rod (Joy, 2005). More recently, a patented “joyride” strut has been incorporated to provide improved dampening.

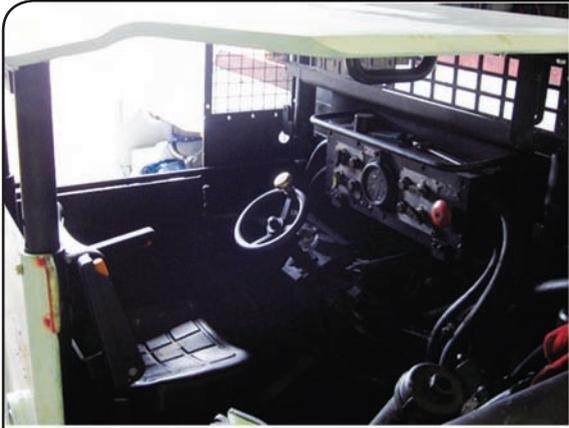
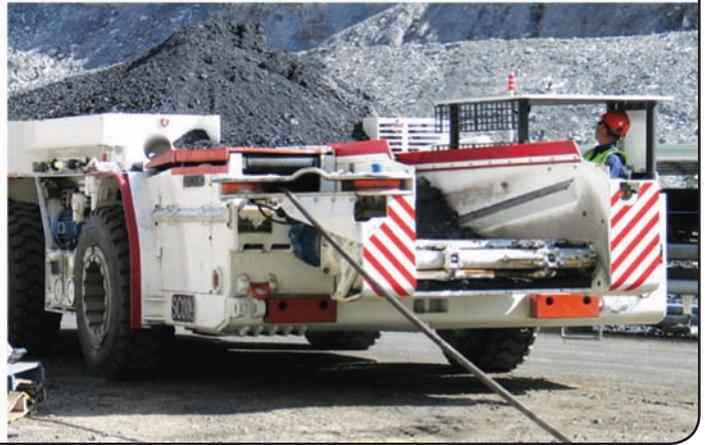
Joy 10SC32BC

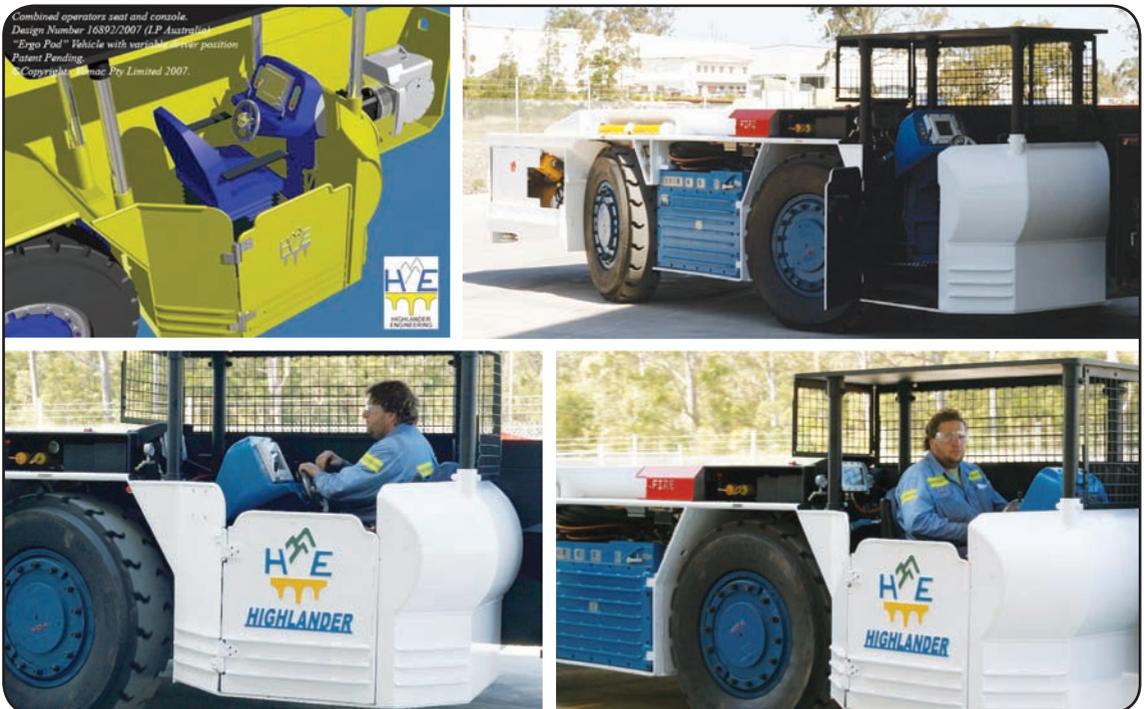
"Ergocab" shuttle car, designed by Highlander Engineering, now owned by PWG Kings & Sons.

One current shuttle car design available in Australia does overcome the directional steering incompatibility issue. This “ergocab” shuttle car features a single rotating seat and steering wheel console and pedals. The directional steering relationship remains consistent regardless of the direction of travel, and awkward neck postures are avoided. The cab is, however, 200-400 mm wider than the shuttle car body to provide the cab space required. These cars also feature a video camera to compensate for the restricted visibility. Video cameras have also been added to Joy cars at the request of at least one Australian mine.

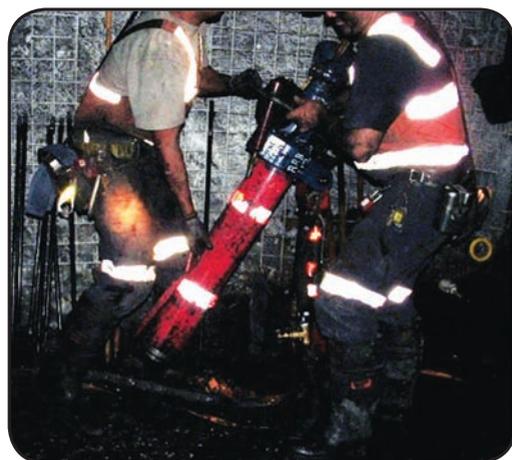
Moving handheld bolter into place
